## **Teamwork lead to successful flushing project in Brazil**

By Lubritech do Brasil

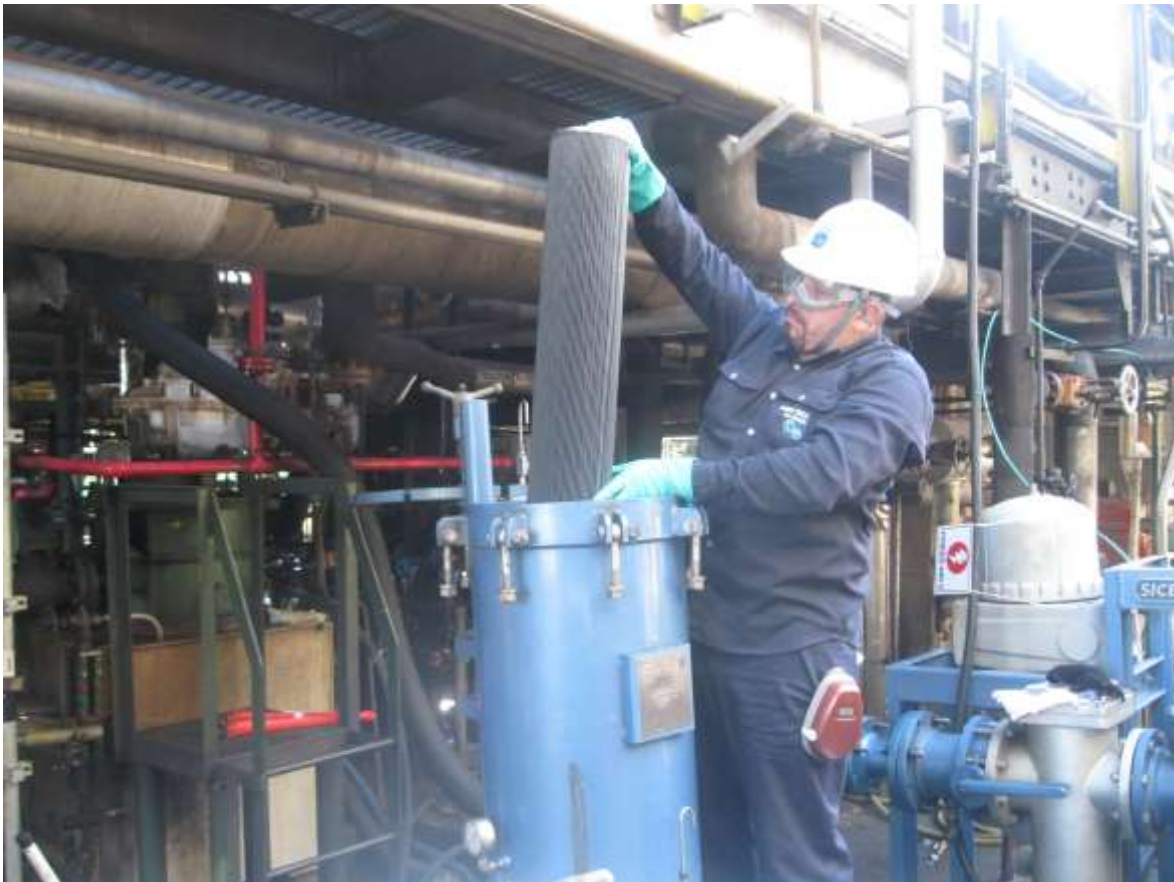
*Filter Change*

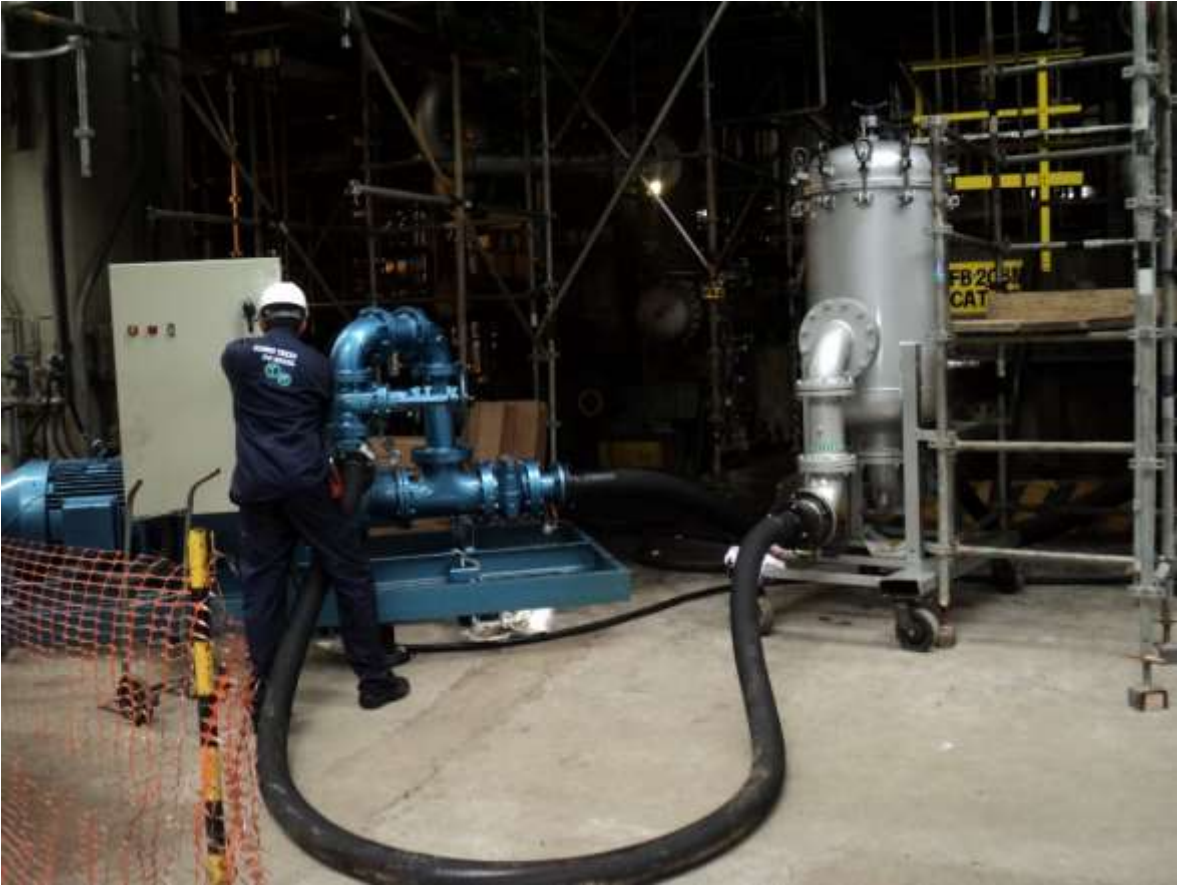
*Flushing Skid*

- Four flushing skids, two 500 GPM, one 1,100 GPM and one 2,200 GPM.
- Four filter housings
- Two 75 Kw electric heaters
- One portable oil analysis kit
- Ten Flushing Supervisors, which Included help from three specialized flushing supervisors from México and two specialized flushing supervisors from Venezuela.

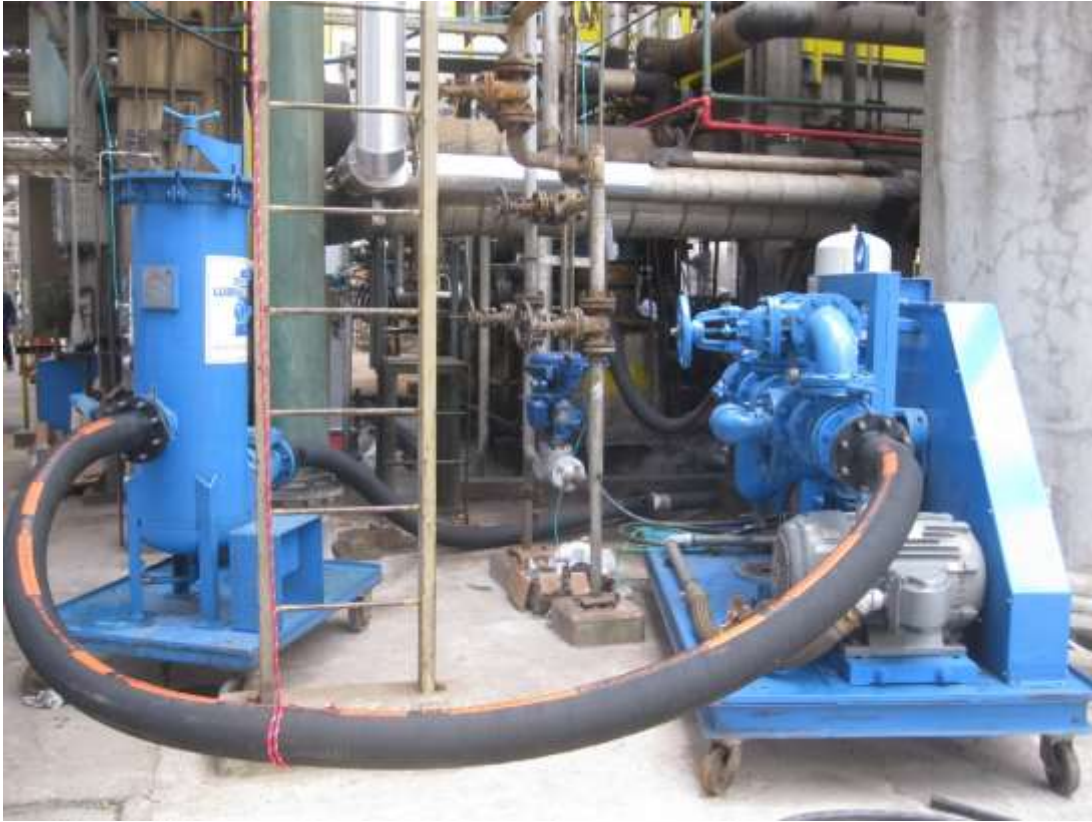
*Flushing skid with positive displacement pump at 500 GPM flow and filter housing with four 34" filter elements.*
